# COATED STEEL SHEET

**ALCOSTA** (Hot-dip aluminized steel sheet)

**MACOSTA** (Hot-dip Zn-Al-Mg alloy coated steel sheet)

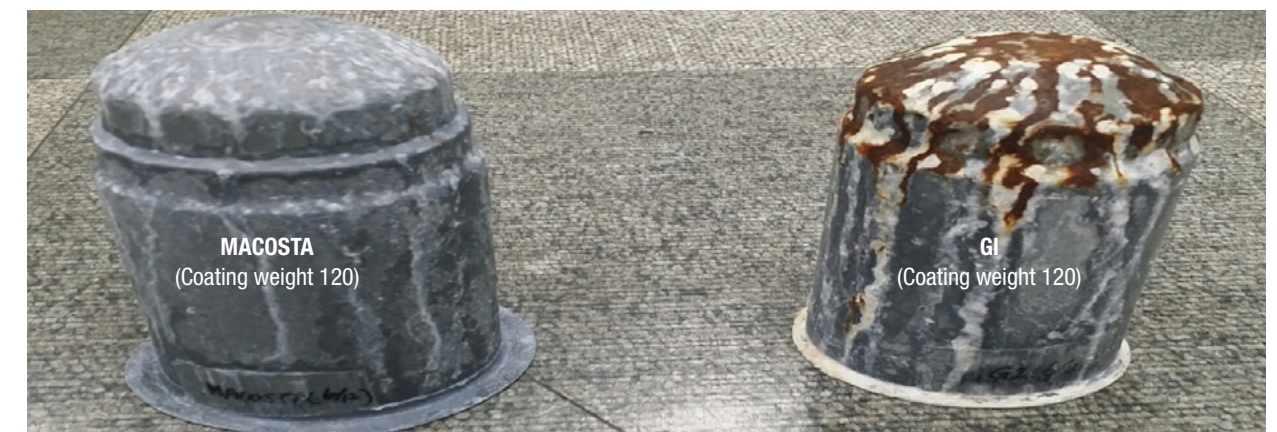
### | Automobile fuel filter housing |

※ No red rust on MACOSTA after 600 hours based on SST → Outstanding formability

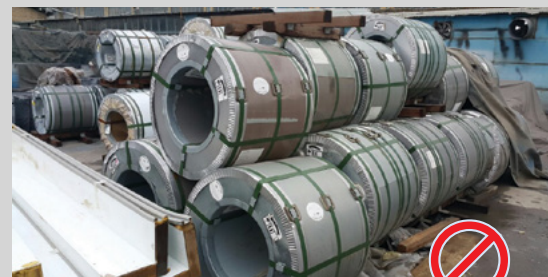
▲ Incorrect outdoor storage (cover not used)
